**ARMORFORM® ARTICULATING BLOCK  
MAT EROSION CONTROL SYSTEM**

**Salmon Creek Bridge  
Oakridge, Oregon**

**Interim Report**

**OREGON EXPERIMENTAL  
FEATURE PROJECT #OR89-05**

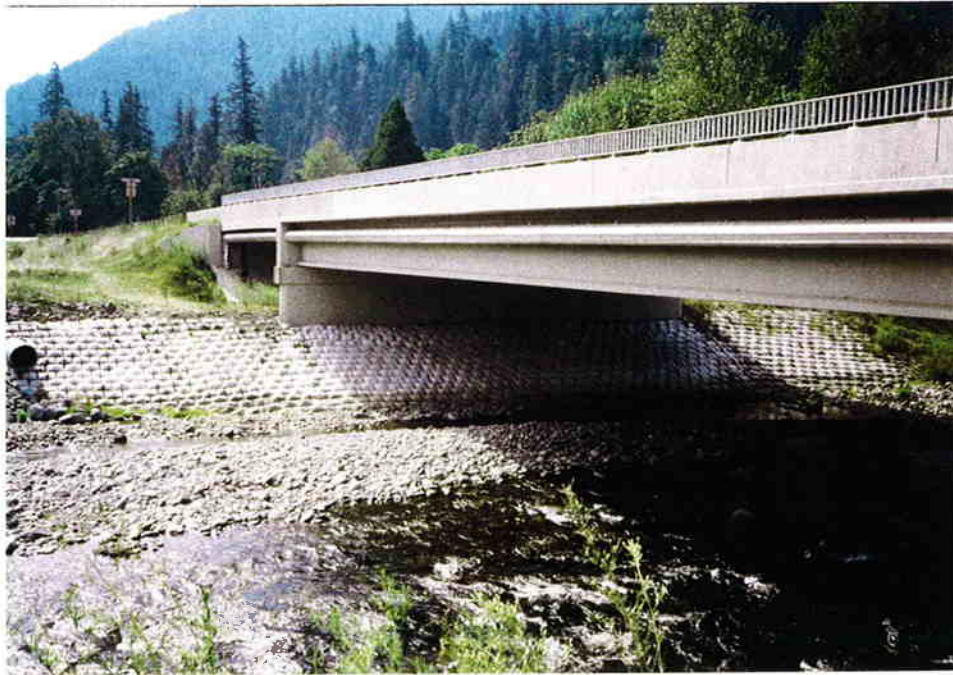
Three detailed inspections have been made at the ABM site since the construction. The ABM has been evaluated for aesthetics, prevention of embankment erosion, prevention of pier and abutment scour, and performance and maintenance compared to loose riprap. The finished ABM is shown in Figure 2.1 which includes a photograph of the mat on the east side of the Salmon Creek Bridge.

Evaluating the aesthetic value of the ABM is difficult because it is a subjective quality. One opinion of the mat was that it was too white and uniform, so it did not blend in with the natural setting. Another opinion was that the mat looked nice and provided a finished look to the embankment. During the site visits, it was noted that the fabric enclosing the grout is slowing wearing away. As the material degrades, the gray grout will be exposed which may appear more natural looking. An additional visual effect is the staining that occurs on blocks that are submerged during high water. As the water level recedes in the summer months, the blocks are exposed and appear several shades darker than the higher blocks.

**Figure 2.1. ABM on East Side of Salmon Creek Bridge.**

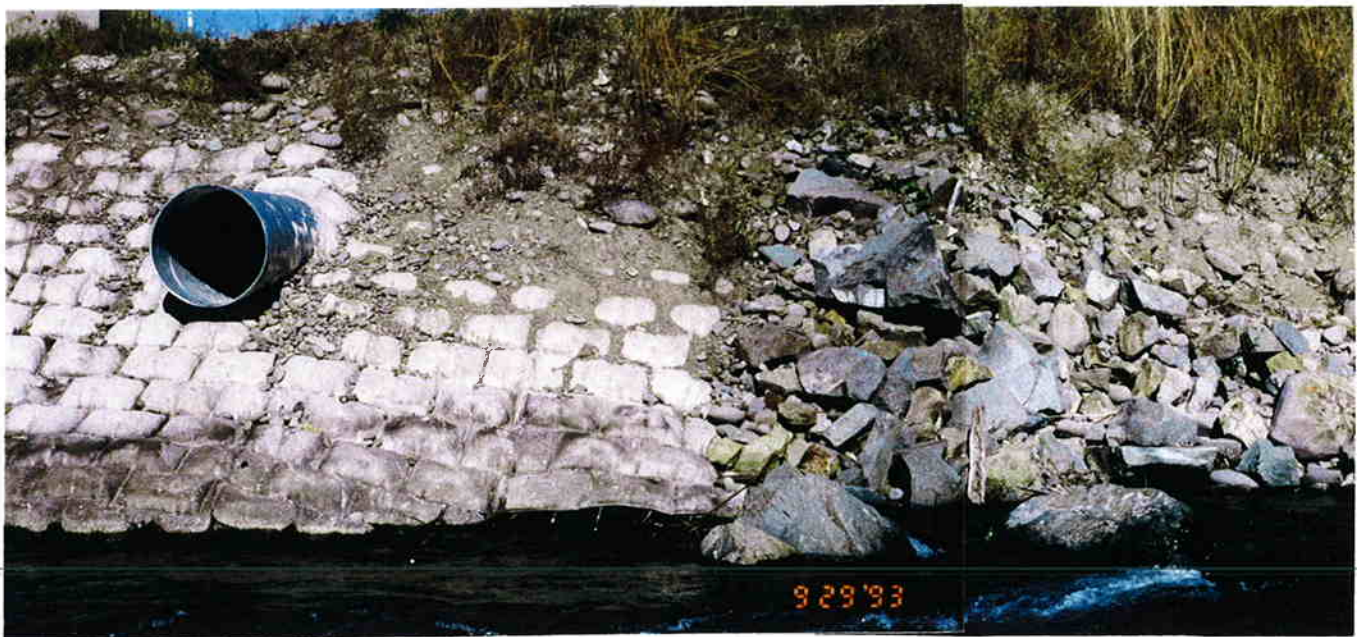
In general, the ABM appears to be preventing embankment erosion, and pier and abutment scour. The only concern is the northwest (upstream) corner. The northwest corner of the ABM is currently exposed with a 1 foot gap between the existing embankment and the edge of the ABM projecting into the creek. As noted earlier, riprap was added during construction at this location to protect the mat and prevent additional erosion. More riprap was added by ODOT maintenance staff a year later when excess material was available. Figure 2.2 shows a photograph of the erosion occurring at the corner. During site visits, it was noted that the downstream, southwest corner of the mat was also exposed. Both the northwest and southwest corner exposure can be attributed to the change in design from the original ODOT proposal to that provided by the manufacturer. As a consequence, the ABM was not buried to full depth on both sides of the pier. Because of the potential for the creek to flow behind the mat, the northwest corner is more critical than the southwest corner in the overall performance of the ABM.

The mat appears to be performing better than standard riprap. Since the streambed has a tendency to degrade, riprap could potentially be undermined leaving an exposed slope. This is evident on the northwest side of the mat where the bank has been undermined and riprap has rolled into the creek. As more and more riprap is lost into the creek, maintenance will be required to restore bank protection. ABM provides an added advantage over riprap since trees do not seed in on the ABM. Trees may present a site distance obstruction and/or make it difficult for maintenance workers to get access under a bridge.

**Figure 2.2. Northwest (Upstream) Corner of ABM.**

The ABM is performing as intended. The northwest corner, however, should be inspected regularly to insure that it is properly protected. During a major flood event, the creek could flow behind the ABM leading to failure.

The plans required that all edges of the ABM be keyed in; however, the ABM was not keyed in due to the limitations of the product. Future ABM projects should require all edges be keyed in and protected with riprap to prevent undermining and flow behind the mat.
